How Reliable Are Your Vari-Nozzles?

By MMCM(SS) John Mosholder,
Naval Safety Center

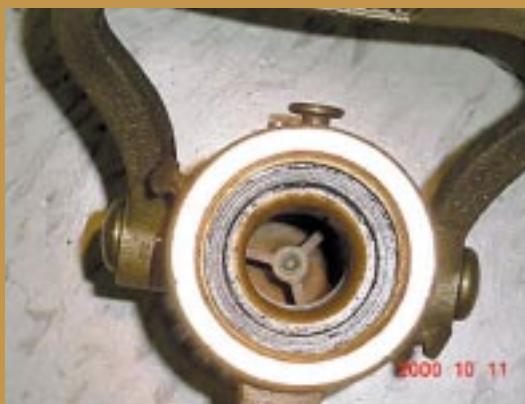
You can identify earlier design nozzles by looking into the open valve through the coupling end. If you see a three-legged brass part (known as a stem-base web) the nozzle may be defective. The nozzle poppet-and-stem assembly system in the center of the discharge end screws into this part. The entire assembly should move freely, in and out, with approximately one-quarter-inch of travel. The brass stem base can corrode to the nozzle body, which locks the poppet-and-stem assembly in the low- or no-flow position.

Three-legged (potentially defective)

You can repair defective nozzles by replacing the three-legged, brass stem-base. Order the replacement part and installation instructions from:

When ordering the replacement part, be sure to include your complete mailing address and specify that you're ordering the stem-base web, part No. 63420000. For more ordering help, contact Debbie Welsch at (219) 295-8330, ext. 240. The company's Fax number is (219) 293-9914.

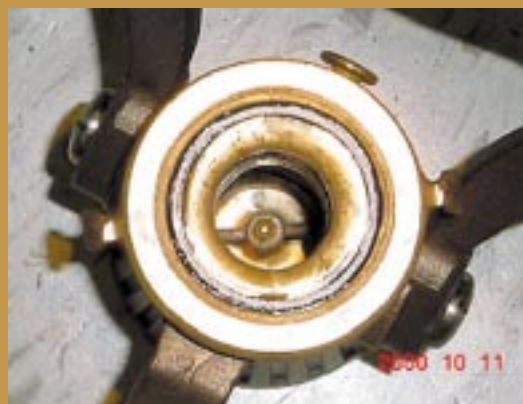
Whether or not the assembly moves, you must remove the nozzle from the hose to inspect it for the potentially defective part. Later model vari-nozzles have a rigid, cast-in-place, two-legged stem base and are not susceptible to the corrosion-caused failure.

Later version (no action required)
